## Site Investigation Report

**WHC reference:** 8218

**Client:** BVS Subsidence Ltd

Address: 93 Main Street, Little Downham, Ely, Cambridgeshire, DB6 2SX

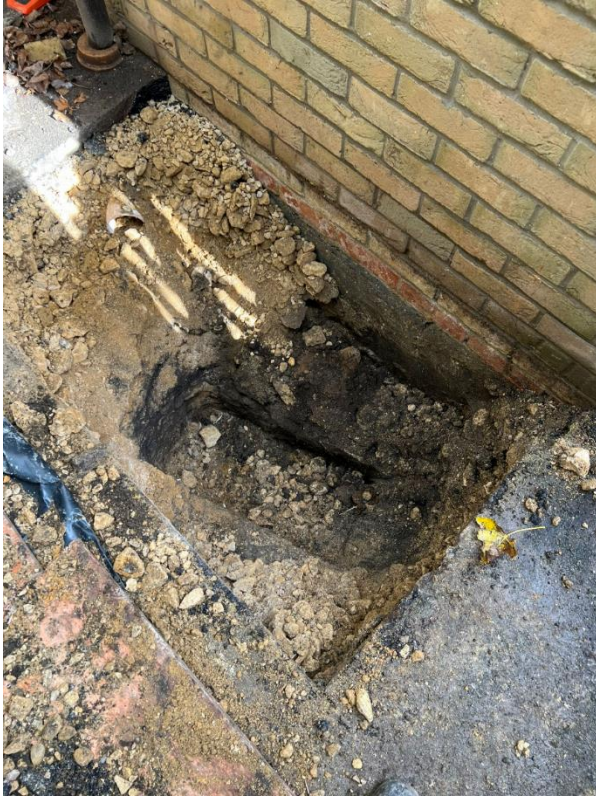
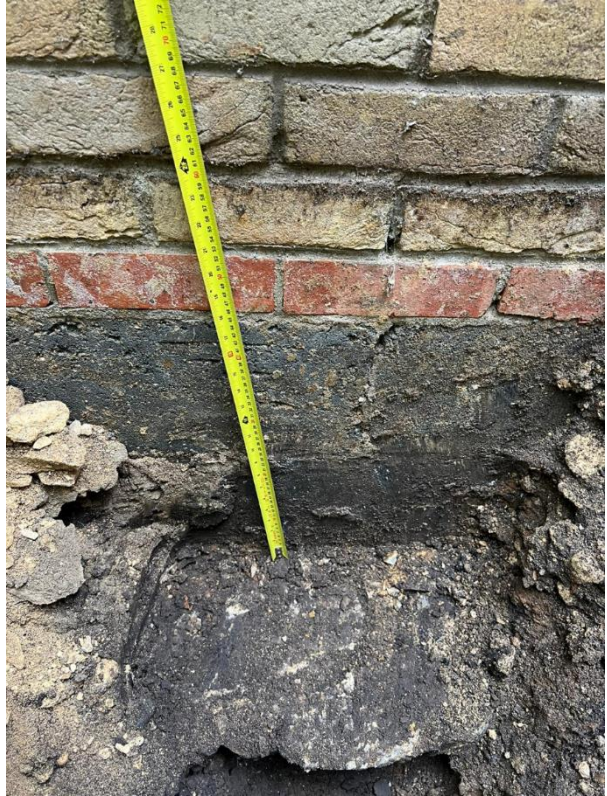
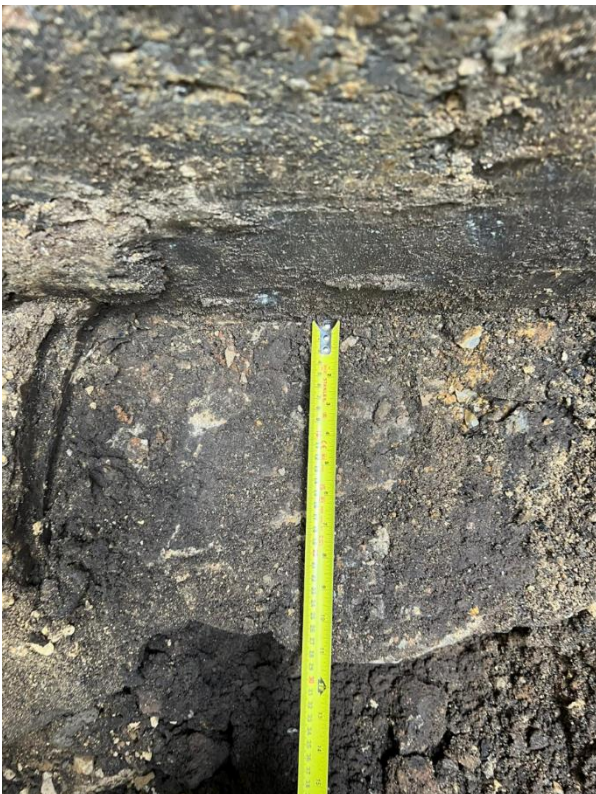
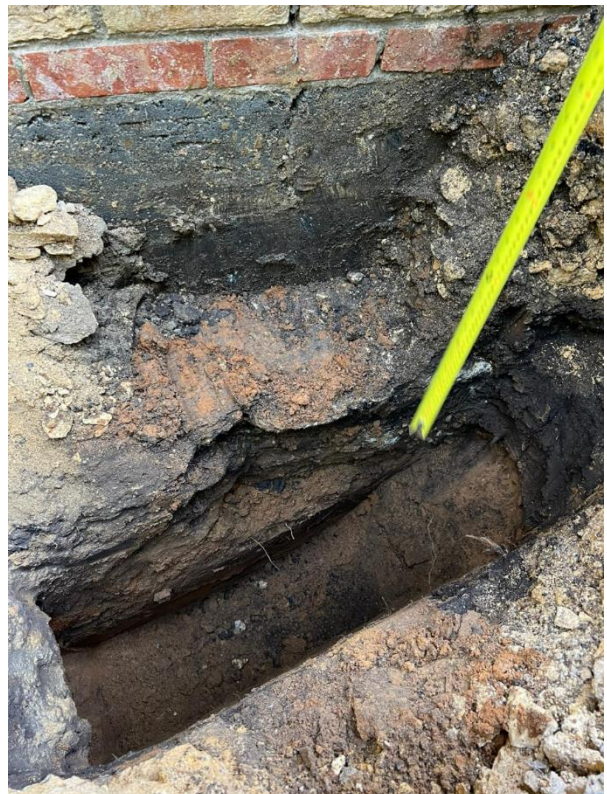
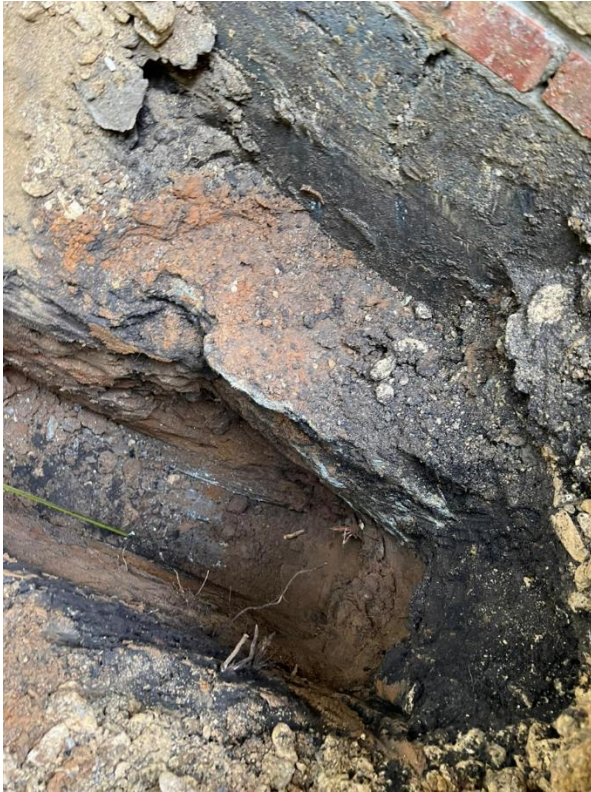
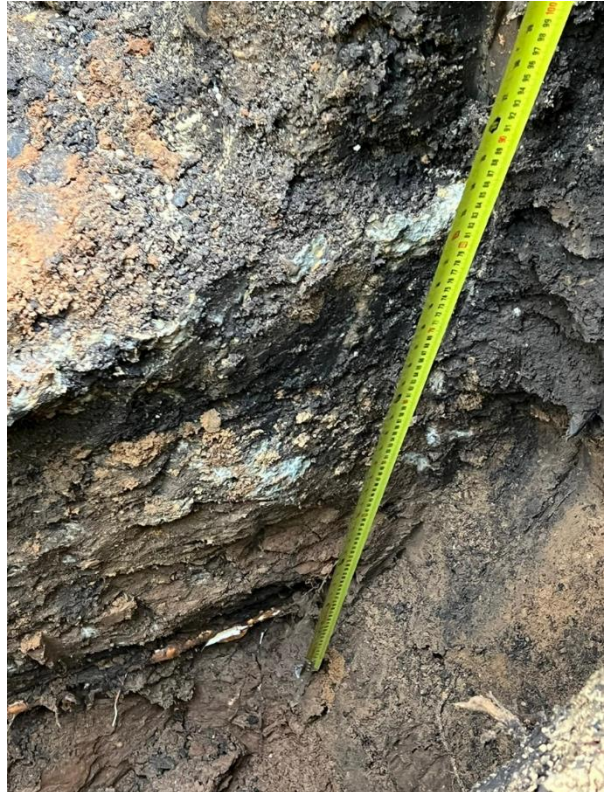
Trial Pit Details can be found in Appendix A, where in trial pit 1, a 750mm thick concrete footing was founded at a depth of 1.30m below ground level, with a 280mm projection. Trial Pit 1 found Tarmac to a depth of 0.08m below ground level, followed by Made Ground MOT to a depth of 0.38m BGL. Made Ground consisting of topsoil and clay was then recorded to a depth of 0.68m BGL, followed by Sand to 1.28m BGL. Below this, firm very dry silty Clay was encountered to a depth of 1.38m BGL, underlain by firm to stiff very dry grey Clay with chalk fragments to 2.25m below ground level, becoming stiff at 1.85m, at which point the trial pit was terminated due to refusal. Trial Pit did not encounter groundwater, with roots present at 0.88m, 1.25m, 1.30m, 1.40m, 1.70m and 2.20m.

Root Identification Results can be found in Appendix B, where in trial pit 1, multiple Cupressaceae roots were identified at depths of 0.88m, 1.25m and 1.40m with root diameters of 4mm, 3mm and 3mm, respectively.

Trial Pit 1 also identified multiple Populus roots at depths of 1.25m, 1.30m, 1.40m, 1.70m and 2.20m with root diameters of 2mm, 23mm, 1.50m, <1mm and 2mm. Starch absent in all roots encountered, with all roots in a state of decay.

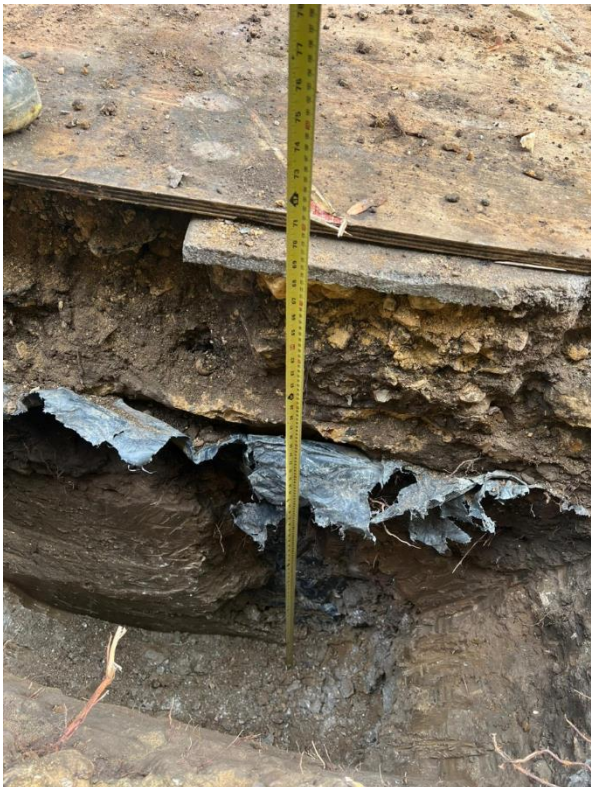
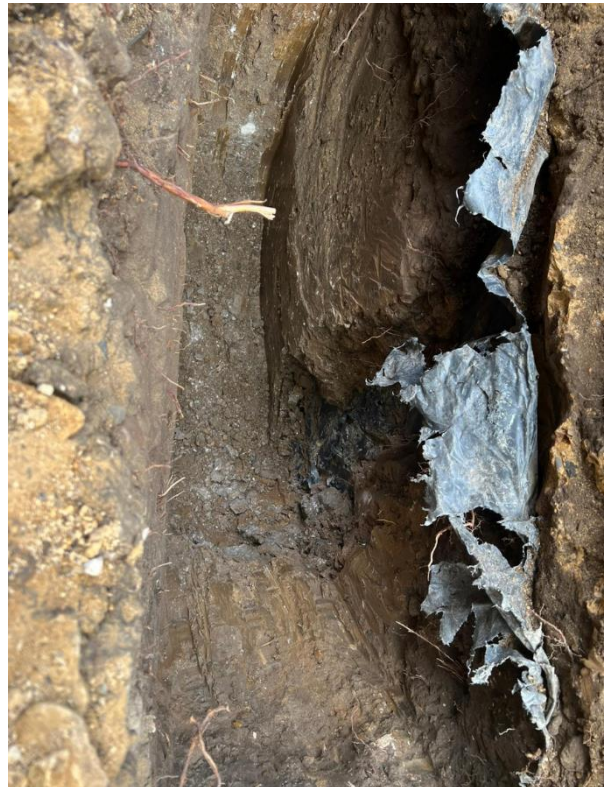
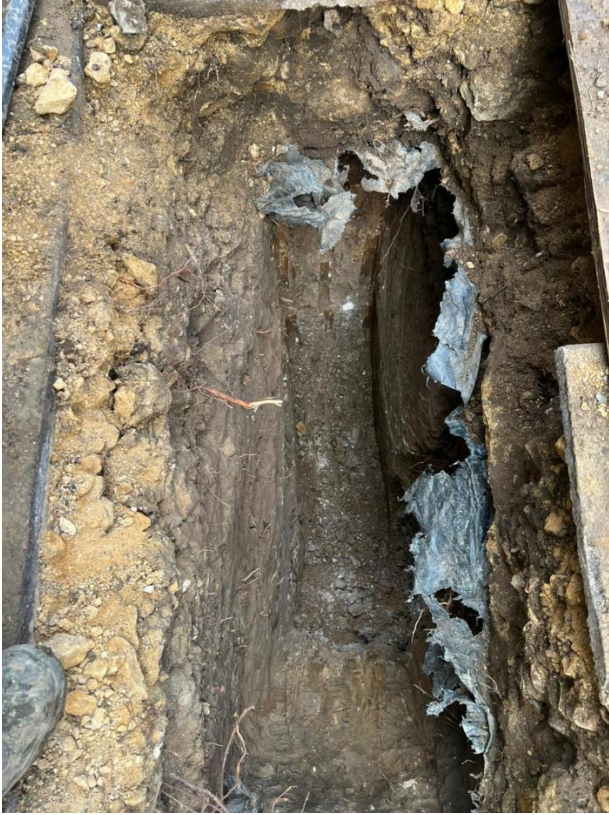
In trial pit 2, a root barrier was encountered to a depth of 1.73m below ground level. Trial Pit 2 found Tarmac to a depth of 0.08m below ground level, followed by Made Ground MOT to a depth of 0.30m BGL. Made Ground consisting of topsoil and clay was then recorded to a depth of 0.60m BGL, underlain by sand to 1.20m BGL. Below this, firm to stiff very dry grey Clay with fragments of chalk was encountered to a depth of 1.80m BGL, at which point the trial pit was terminated.

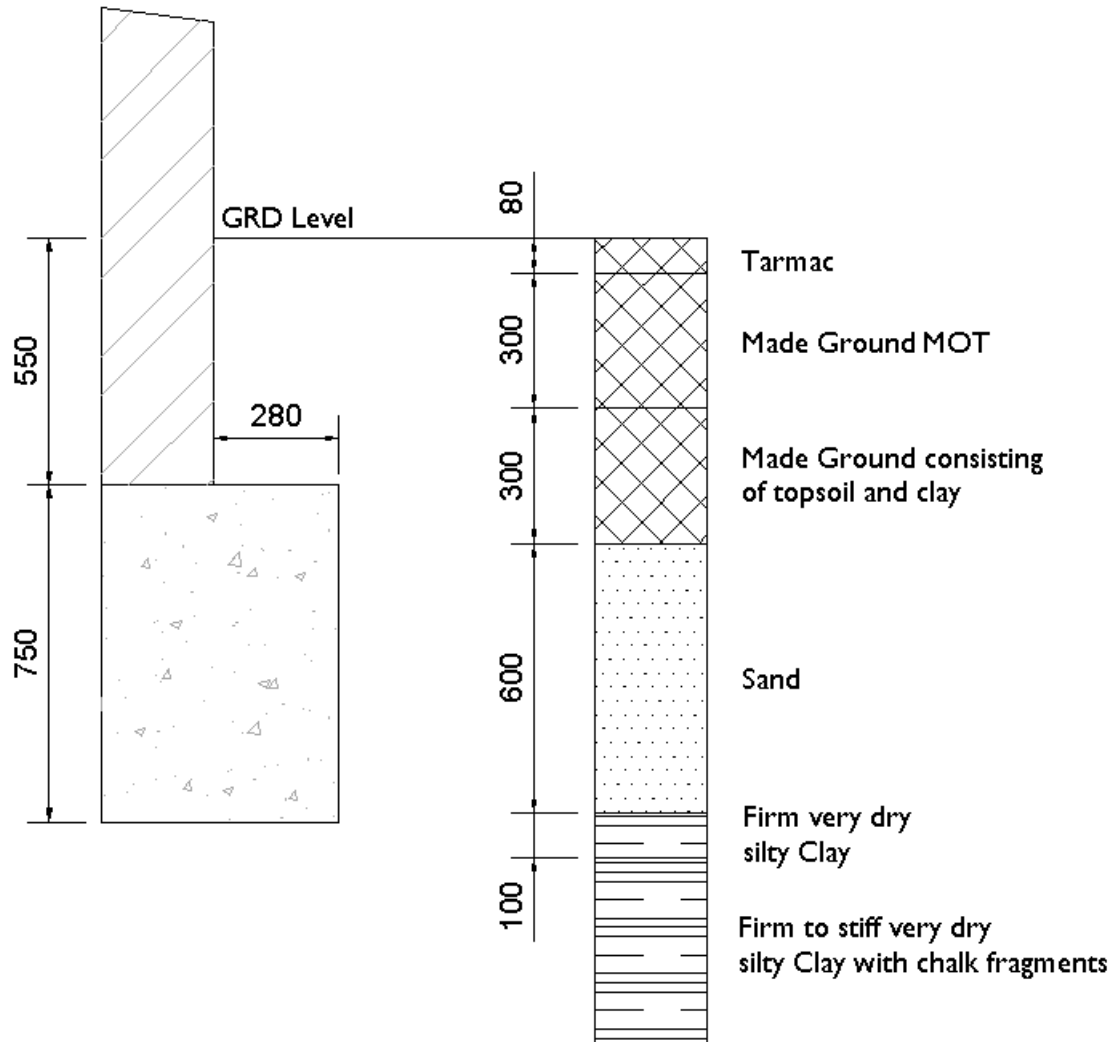
#### Trial Pit I

Well	Water Strikes	Sample and In Situ Testing			Depth (m)	Legend	Stratum Description
		Depth (m)	Type	Results			
		1.30	D		0.08	Tarmac.	
					0.38	Made Ground MOT.	
					0.68	Made Ground consisting of topsoil and clay. <u>Top of footing at 0.55m.</u>	
					1.28	Sand.	
					1.38	Firm very dry silty Clay. <u>Bottom of footing at 1.30m.</u>	
		2.25	D		1.38	Firm to stiff very dry grey Clay with chalk fragments.  <u>Becoming stiff at 1.85m.</u>	
					2.25	End of Borehole at 2.250m.

Remarks  
Trial Pit was terminated at 2.25m below ground level due to refusal. Trial pit did not encounter groundwater, with roots present at 0.88m, 1.25m, 1.30m, 1.40m, 1.70m and 2.20m.

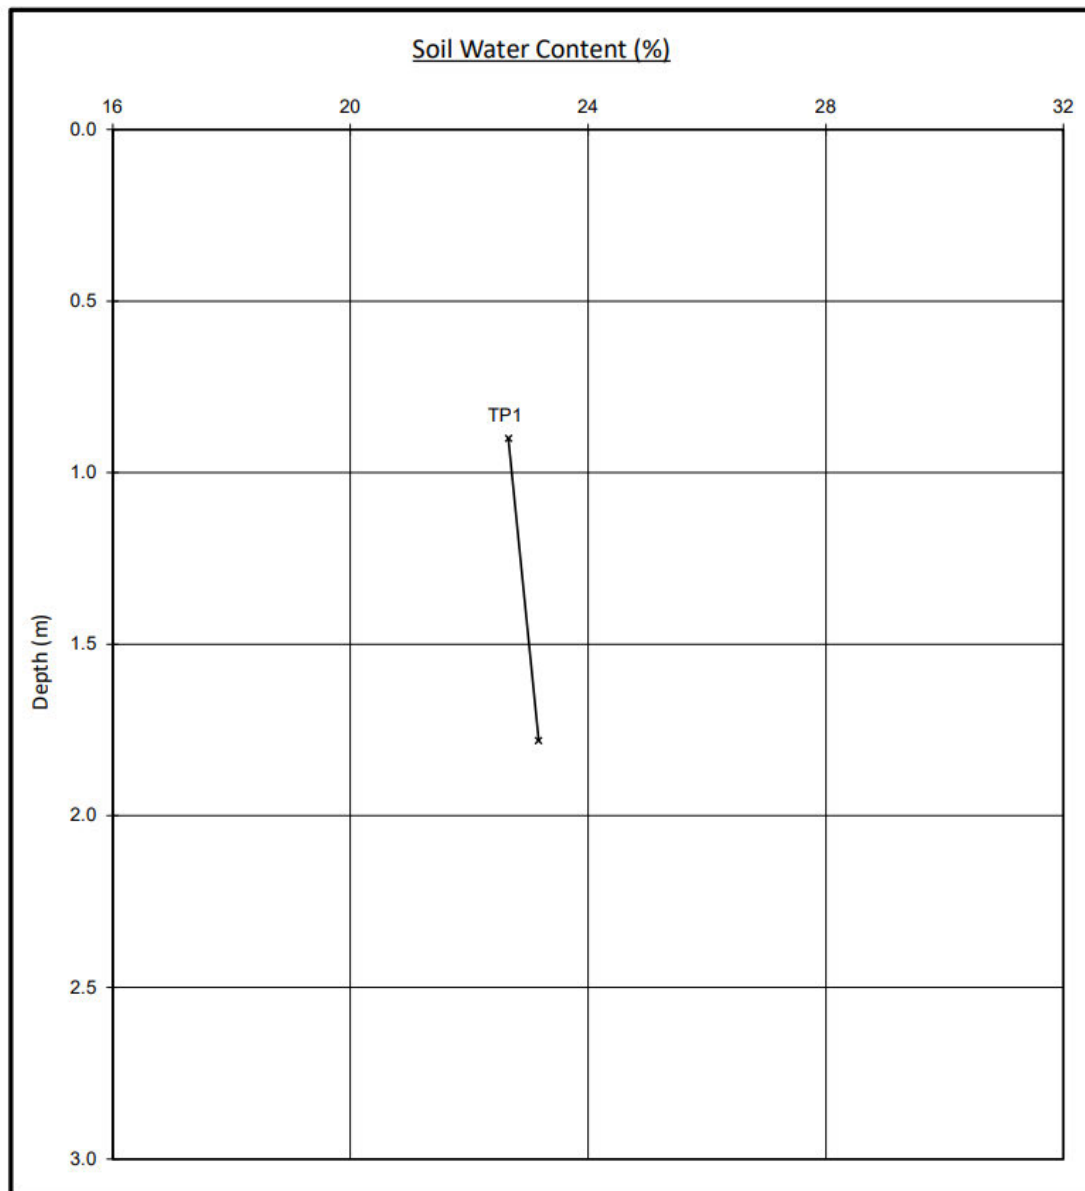
# Water Content Profiles

TP/BH No	Sample Ref		Type	Water Content (%) [2]	Soil Fraction >0.425mm (%) [2]	Liquid Limit (%) [3]	Plastic Limit (%) [4]	Plasticity Index (%) [5]	Liquidity Index* [5]	Modified Plasticity Index* (%) [6]	Soil Class* [7]	Filter Paper Contact Time (d)	Soil Sample Suction (kPa) [8]	Roots Present or No Roots Observed* [9]	In situ Shear Vane Strength* (kPa) [10]	Organic Matter O.M. (%) [11]	pH Value [12]	Sulphate Content (g / l)			Class* [15]
	Depth (m)																	SO <sub>3</sub> [13]	SO <sub>4</sub> [14]		
TP1	0.5 - 1.3		D	22.7	<5	53	20	33	0.08	33	CH										
	1.3- 2.25		D	23.2	<5	44	21	23	0.09	23	CI
